57 Bath Covered Bridge

Pettyboro Road, Bath, New Hampshire

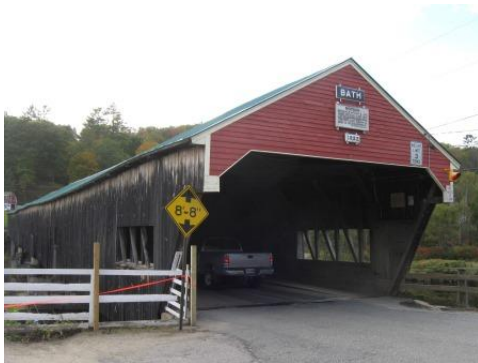
The Bath Covered Bridge is an example of a variation of the popular Burr truss; a combination of an arch and a multiple kingpost truss design. At the time of its construction, the bridge was built with only two piers and three spans, instead of the four that are now present. In the 1920s, the bridge was elevated several feet in order to provide clearance for the growing size of railroad cars. During this process, laminated arches were added, and the wooden piers were probably added at this time as well. A number of repairs were completed between the years of 1939 and 1940, including readjusting the new corrugated metal roof. Almost thirty years later, in 1968-1969, the bridge floor was replanked and other minor repairs were made.
