## 30 Cornish, NH - Windsor, VT Covered Bridge

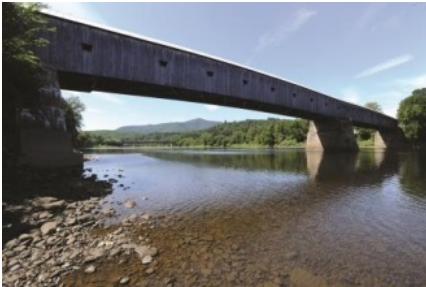
The Cornish-Windsor Bridge spans 450 feet, 5 inches across the Connecticut River, between the east end of Bridge Street in Windsor, Vermont and NH Route 12A in Cornish, New Hampshire. With a roadway width of 19 feet, 6 inches and vertical clearance above the roadway at 12 feet, 9 inches, the covered bridge continues to carry two-way traffic, with a legal weight limit of ten tons.

On the exterior, the trusses (and sidewalls) of the bridge are hung vertically and painted grey. Eighteen small square windows with hoods are evenly spaced and cut into each side wall of the bridge. The windows in one wall are spaced diagonally opposite those in the other wall. Vertical matched boards, which are painted white for increased visibility, protect the ends of the trusses immediately inside the portals. The white gable ends are sheathed with horizontal clapboards. The portal openings are framed with semi-elliptical arches.

While the current structure is void of any modern day structural enhancements, the original physical appearance of the bridge differed somewhat. The original wood-shingled roof was replaced with the metal sheeting in 1924. The matched boards applied to the bridge and painted in 1954-55 most likely replaced flush plain boards, and the stone abutment on the east end has been faced with concrete in 1921 after it started to settle.
